# Manhole Inspection Summary

Manhole # S39A\_\_038MH

Insp Date: **11/5/08 10:27 AM**

**Location** Address: **1110 orleans st**

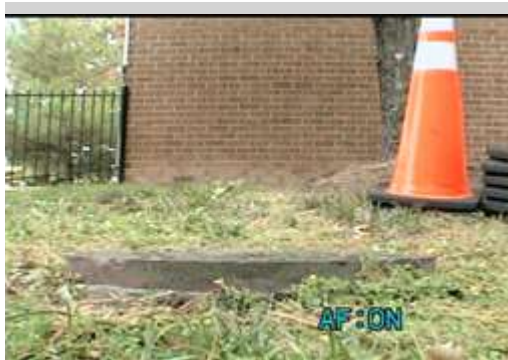
Miscellaneous

Comments **cover doesnt fit in frame**

oversized cover sitting on frame

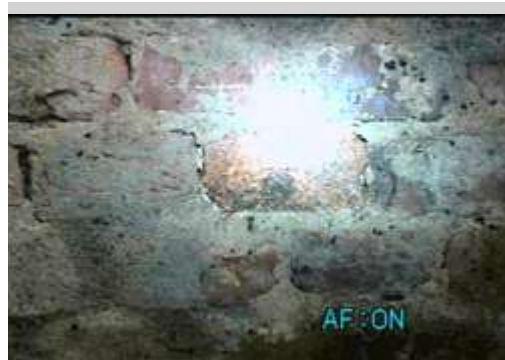
Defect 2

Condition: ☐ Sound ☐ Cracked ☐ Root Intrusion ☐ Loose Brick ☒ **Deteriorated**

corbel deteriorated

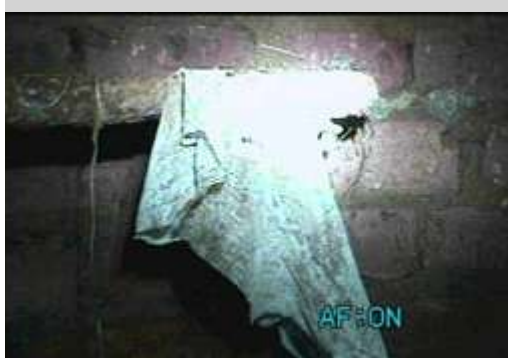
Defect 3

**Surcharge** ☒ **Evidence Of Surcharge** Depth: **4.1** (ft.) ☐ Active Surcharge Present

surcharge evd

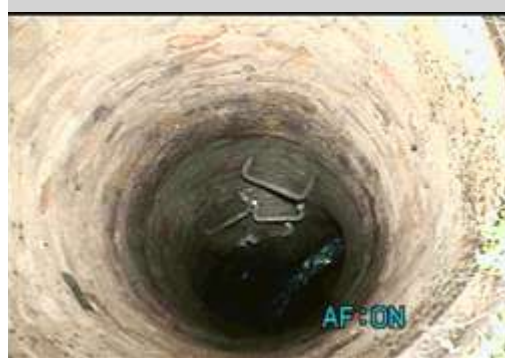
Defect 1

**Steps** Count: **5** Missing: **0** ☒ **Corroded**

corr steps
